THE CALIFORNIA EARTHQUAKE OF APRIL 18, 1906

REPORT

STATE EARTHQUAKE INVESTIGATION COMMISSION

VOLUME I, PART I

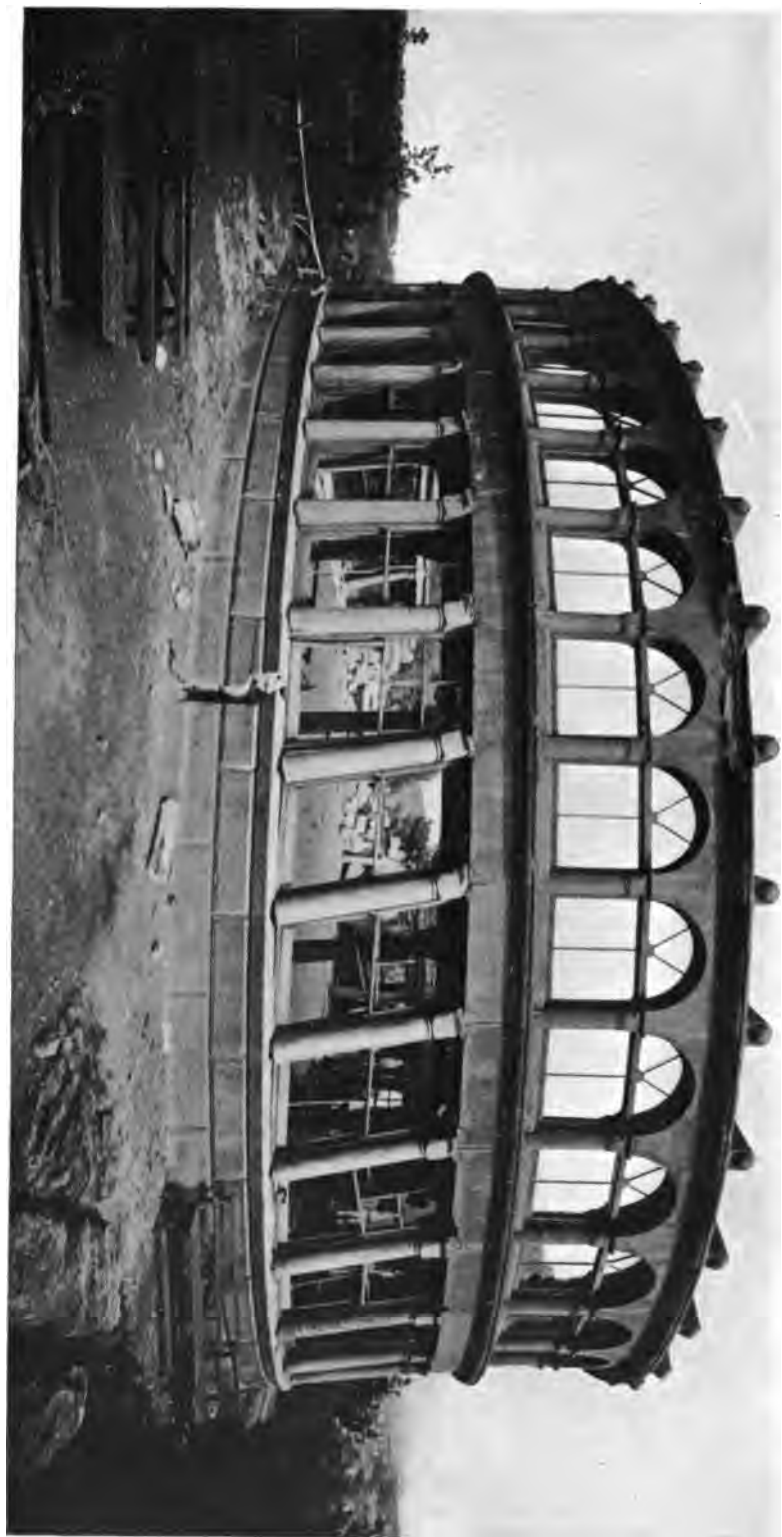
Observatory, Strawberry Hill, Golden Gate Park, San Francisco. W. E. Warden, Photo.

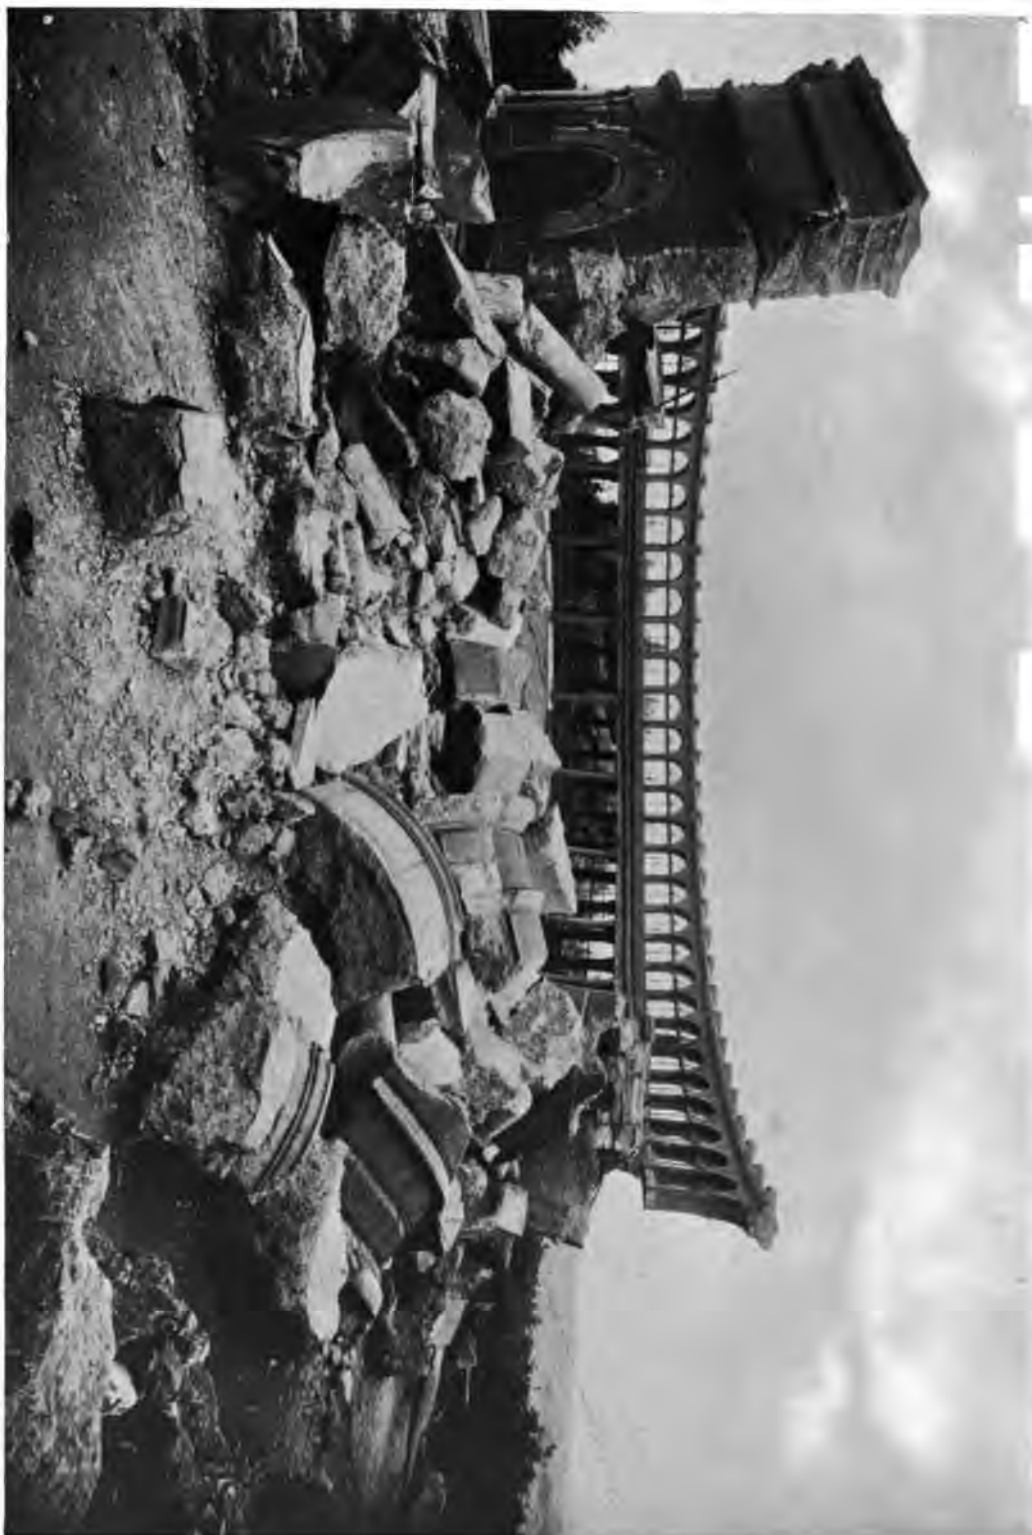
Observatory, Strawberry Hill, Golden Gate Park, San Francisco. W. E. Worden, Photo.

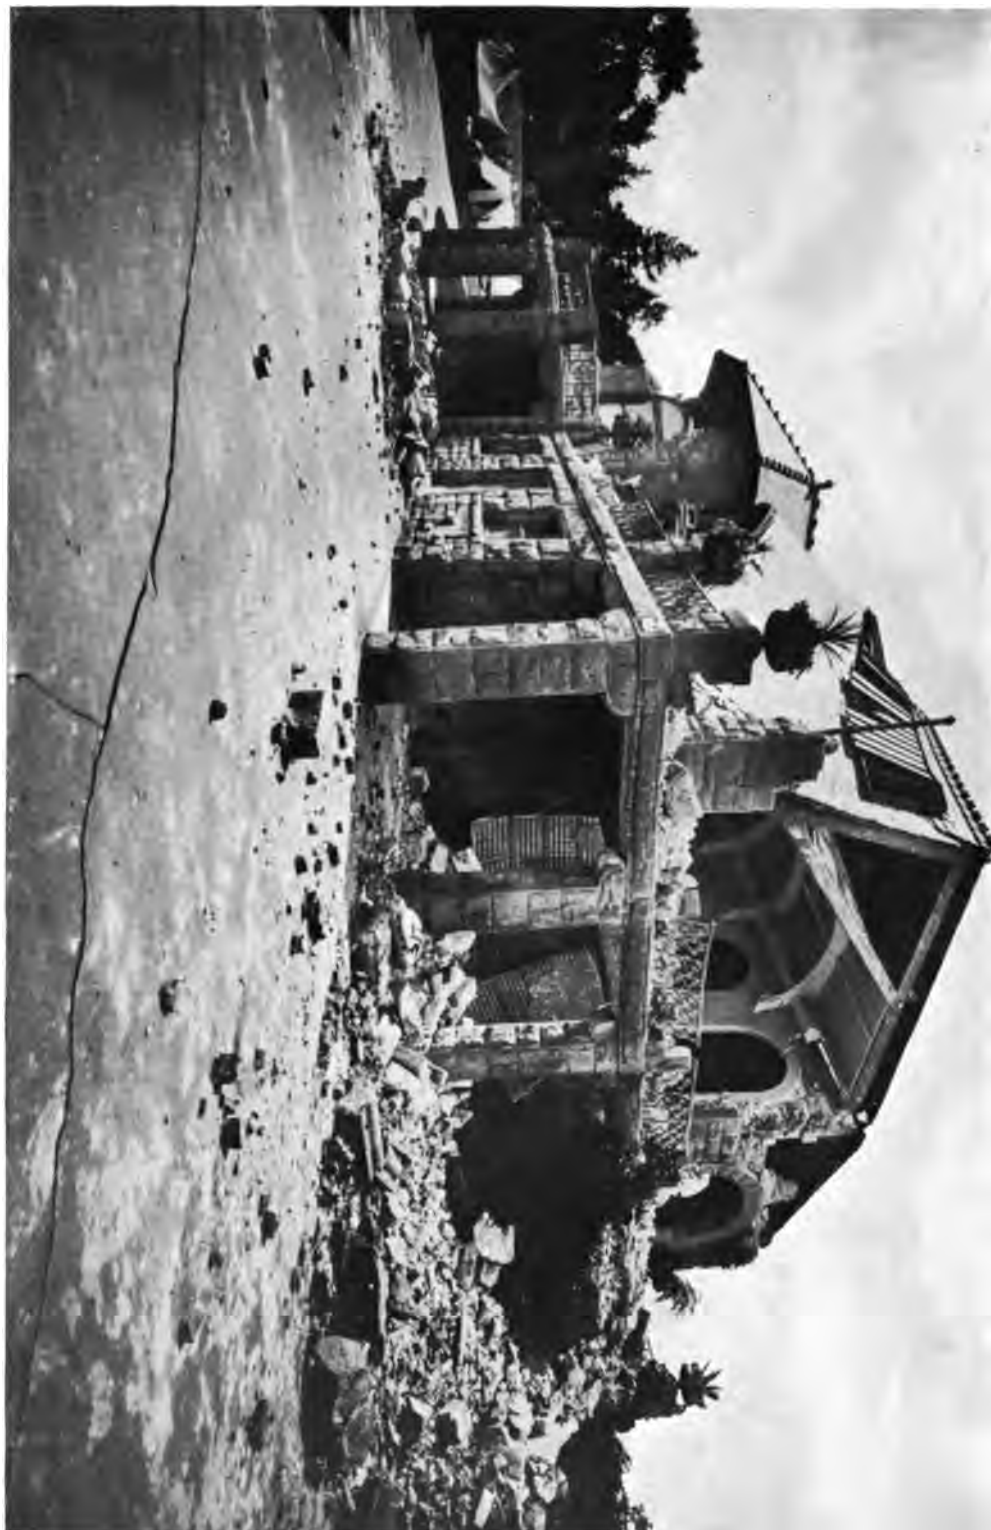
The Park Emergency Hospital, near the southeast corner of Golden Gate Park, had its walls badly cracked and its gable thrown out. It is a small, 1-story, sandstone building, with a wooden frame. Its site was loose sand of unknown depth, probably extensively graded. Evidently it was not an excellently built structure. The restaurant at the children's playground in the Park was wrecked. (Plate 86.)

Restaurant at Children's Playground, Golden Gate Park, San Francisco. W. E. Worden, Photo.

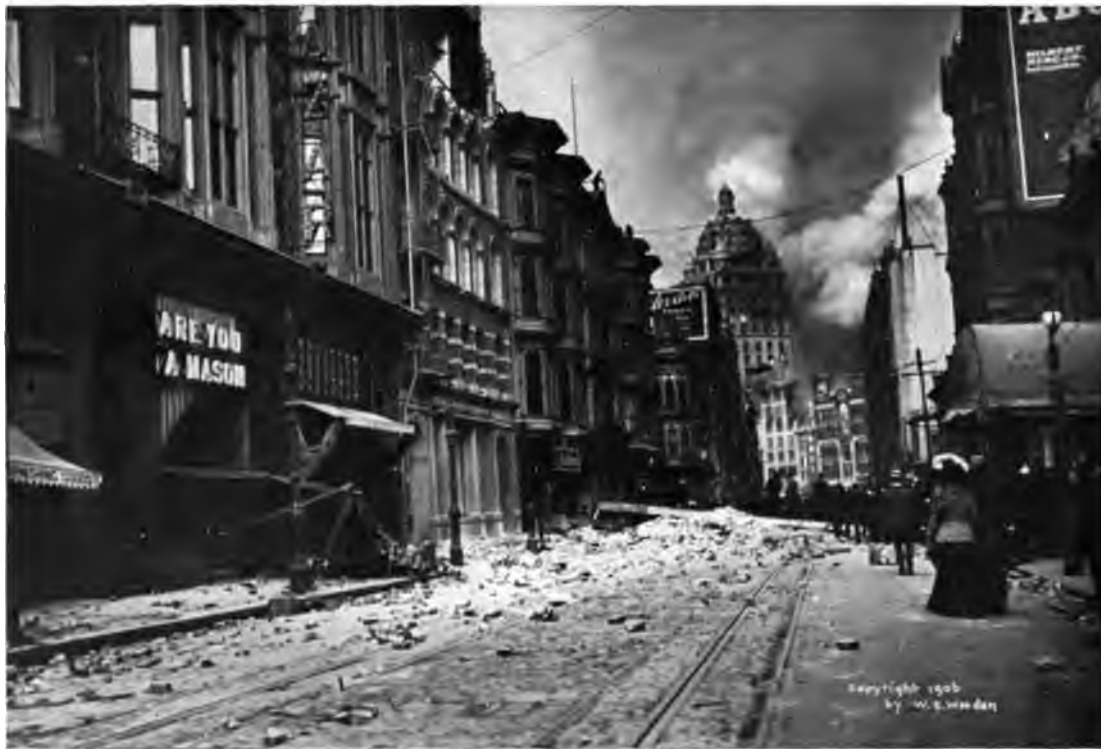
A. O'Farrell Street, San Francisco, after earthquake and before fire.

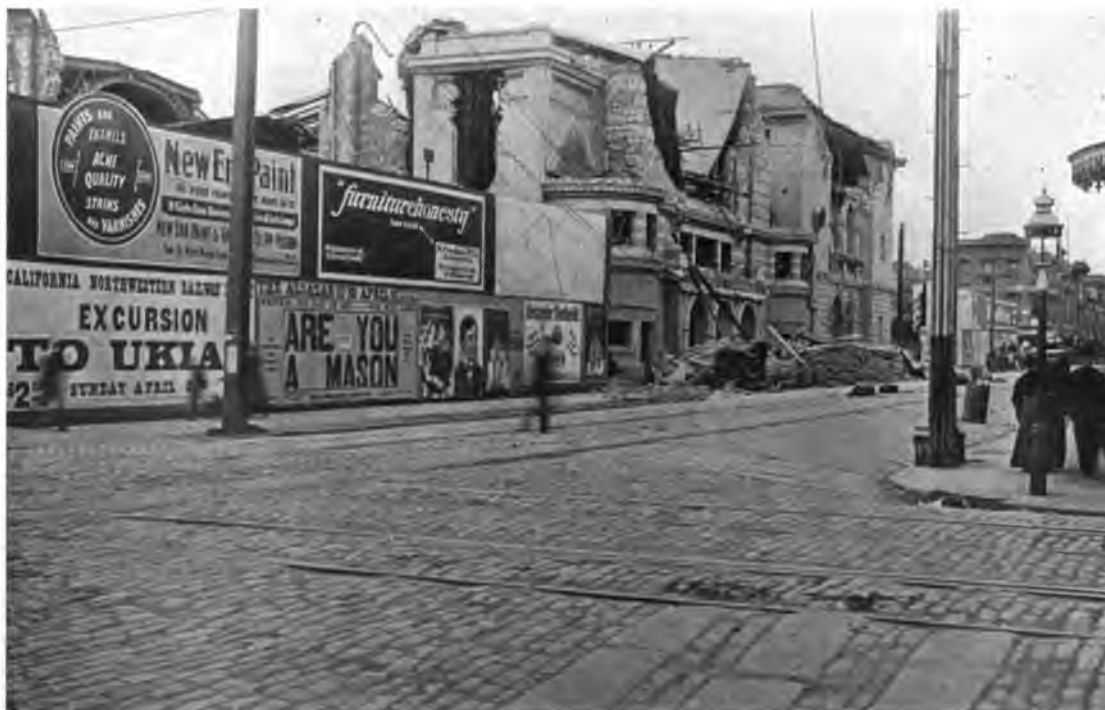
B. Geary Street, between Filmore and Steiner Streets, San Francisco. Buildings of mediocre construction on sand and alluvium of no great depth. A. C. L.

On Geary Street, just above Fillmore Street, two wooden-framed brick buildings standing side by side — the Albert Pike Memorial Temple (Masonic) and a Jewish Synagogue — were utterly wrecked, as the illustration shows. (Plate 87B.) The Girls' High School, near by on O'Farrell Street, at Scott Street, poorly and flimsily built, was badly damaged. Its walls were much cracked and portions of the gable walls were thrown down.

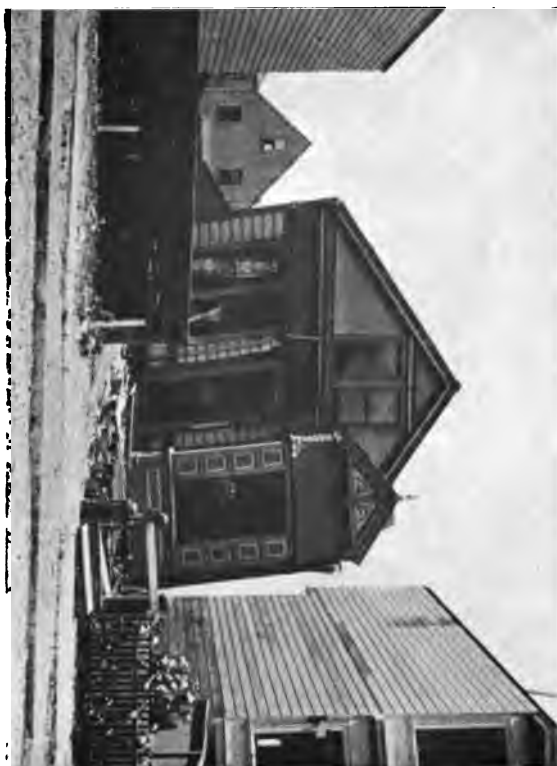
A. Frame building on west side of Eleventh Avenue, just south of California Street, San Francisco. A weak structure, built on sand. H. O. W.

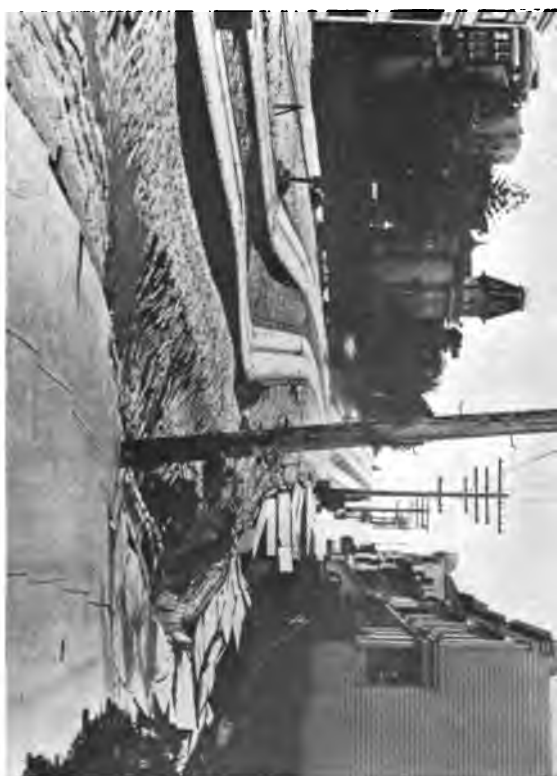
B. Slip of a fill on Union Street, just west of Steiner Street, San Francisco. H. O. W.

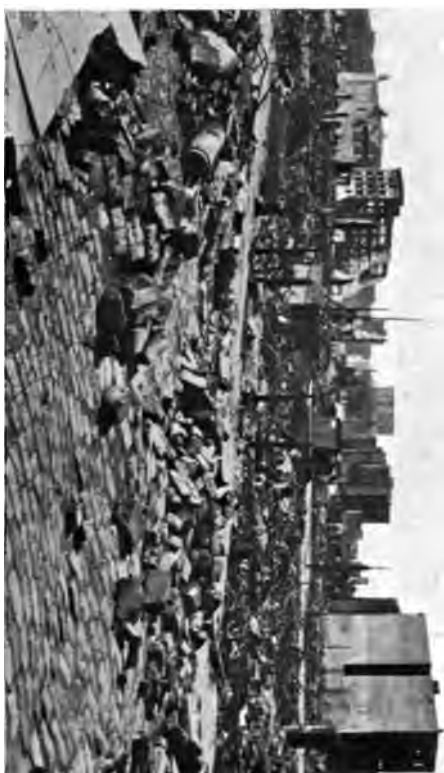
C. Ruas Street, between Polson and Howard Streets, San Francisco. Paving blocks forced up into sharp arches and dislodged by compression. H. O. W.

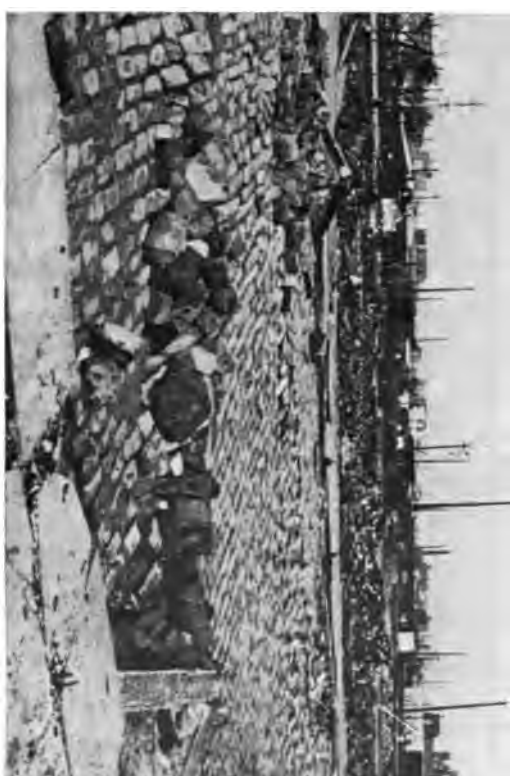
D. Ruas Street, between Polson and Howard Streets, San Francisco. Paving blocks arched by compression along sinuous crest, curbing thrown into an inverted V. H. O. W.

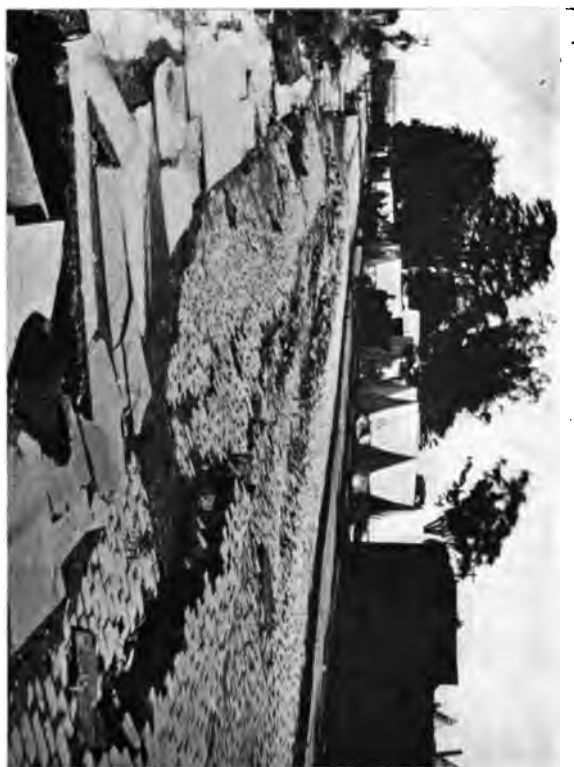
A. Columbia Street, just south of Polson Street, San Francisco. Slumping, depression, and narrowing of block pavement. H. O. W.

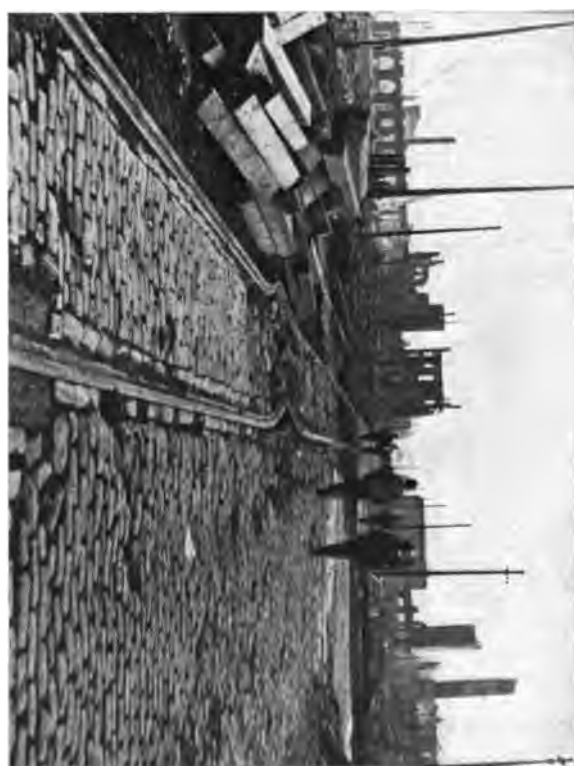
B. Bryant Street, near Fourth Street, San Francisco. Flexure of heavily ballasted car tracks in block pavement; an effect of sharp compression. H. O. W.

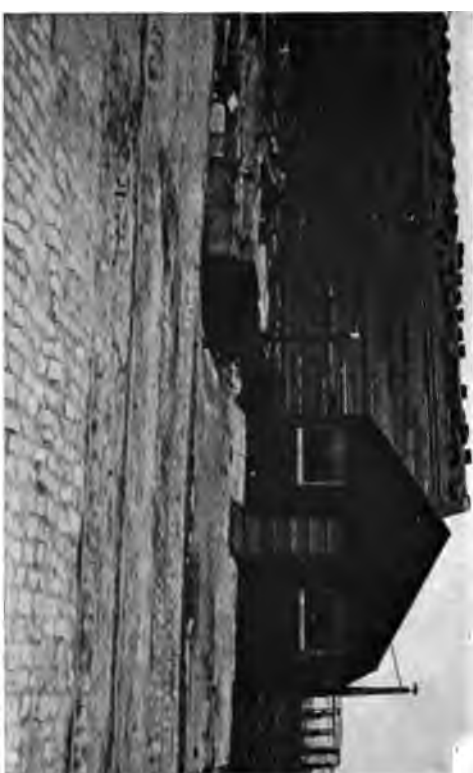
C. Birch Street, near Howard. Once occupied by marsh. Street drops nearly 3 feet. Sidewalk held up by piling foundation of a building. H. O. W.

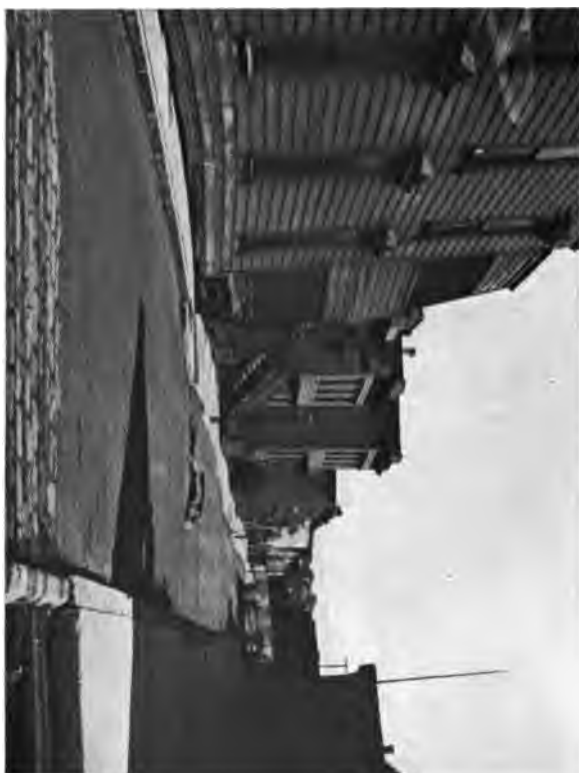
D. Looking along Dore Street, from Bryant toward Brannan. Undulating and fractured condition of pavement due to earthquake. Houses thrown off their underpinning and pitched out of the vertical. H. O. W.

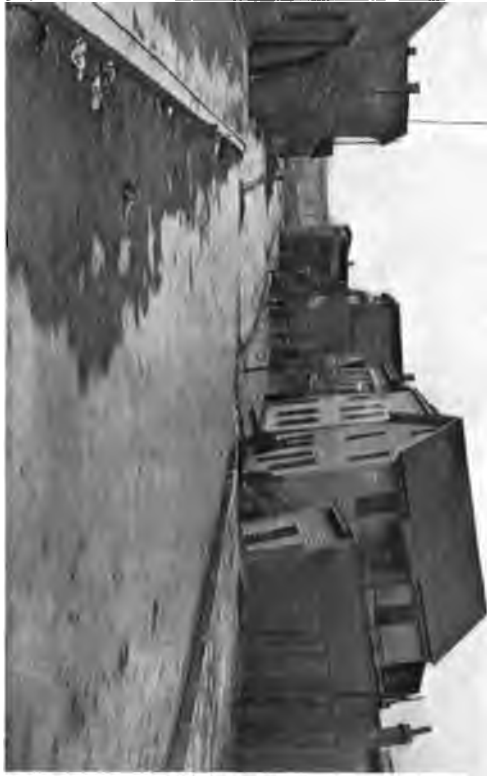
A. Looking along Dore Street from Brannan toward Bryant. Larger undulations near Brannan. Dore Street is on site of an arm of Mission Creek. H. O. W.

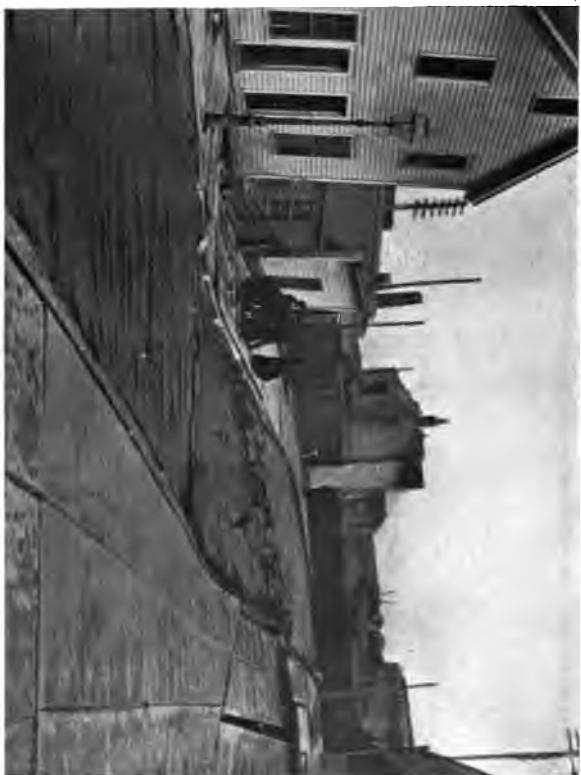
B. Dore Street, near Brannan. Vertical difference between crest and trough of undulations, 6 feet. H. O. W.

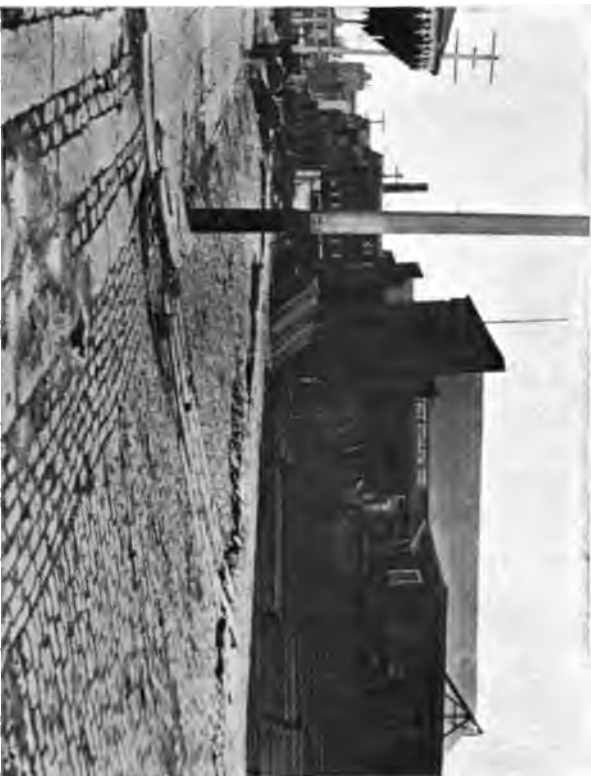
C. Eighteenth Street, just east of Shotwell. Flaring and depression of pavement. H. O. W.

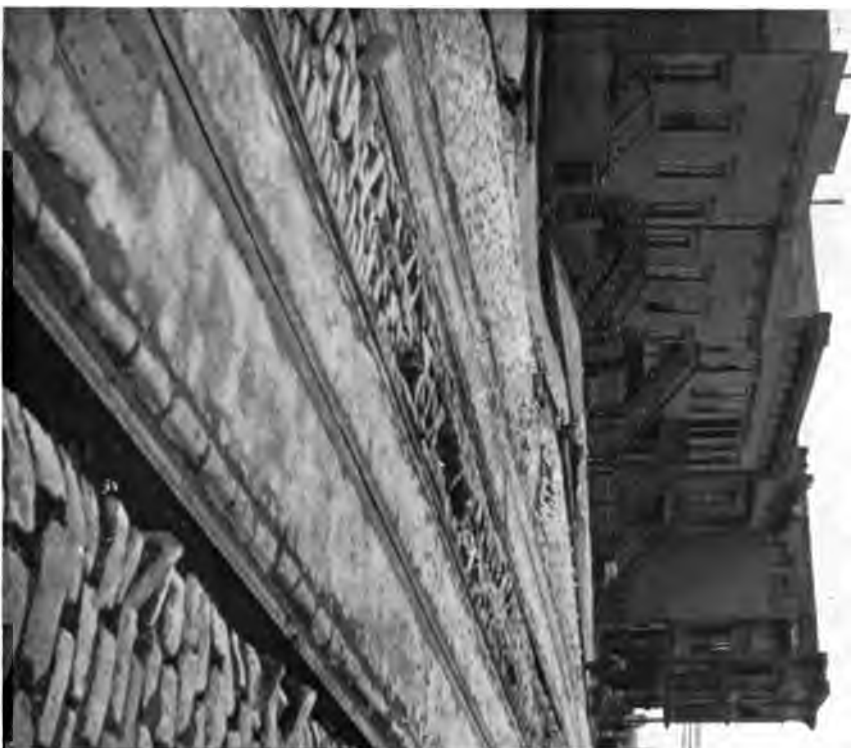
A. Ninth Street, between Bryant and Brannan. Undulation and fanning of pavement and sidewalks. Houses over-trough have been dropped from their underpinning. G. K. G.

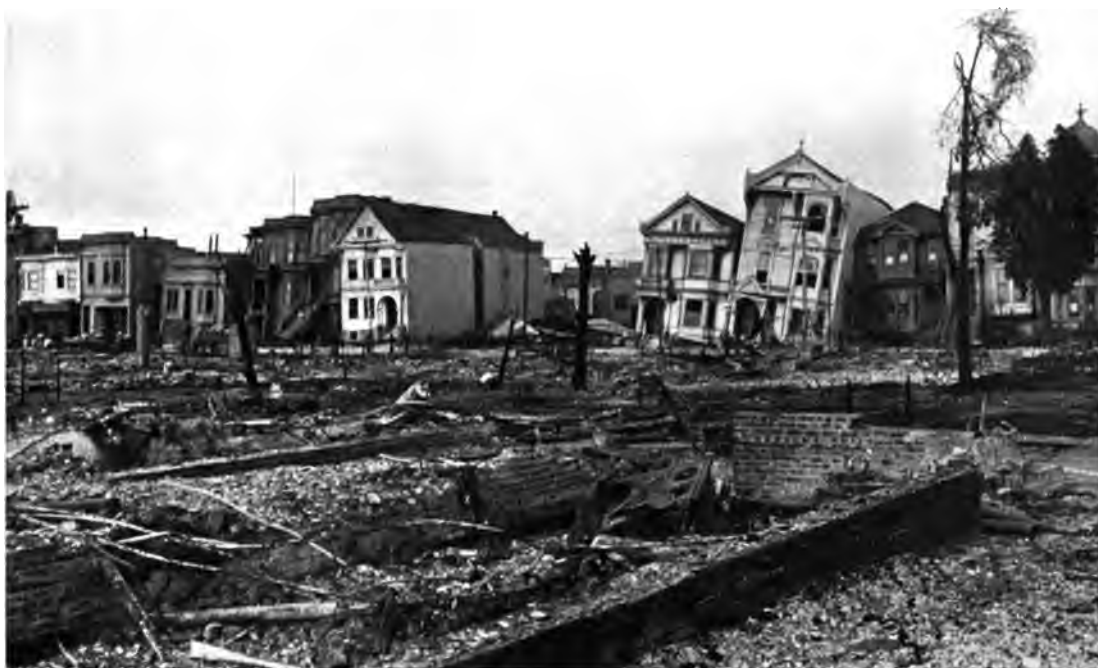
A. East side of Howard Street, between Seventeenth and Eighteenth Streets. A. O. L.

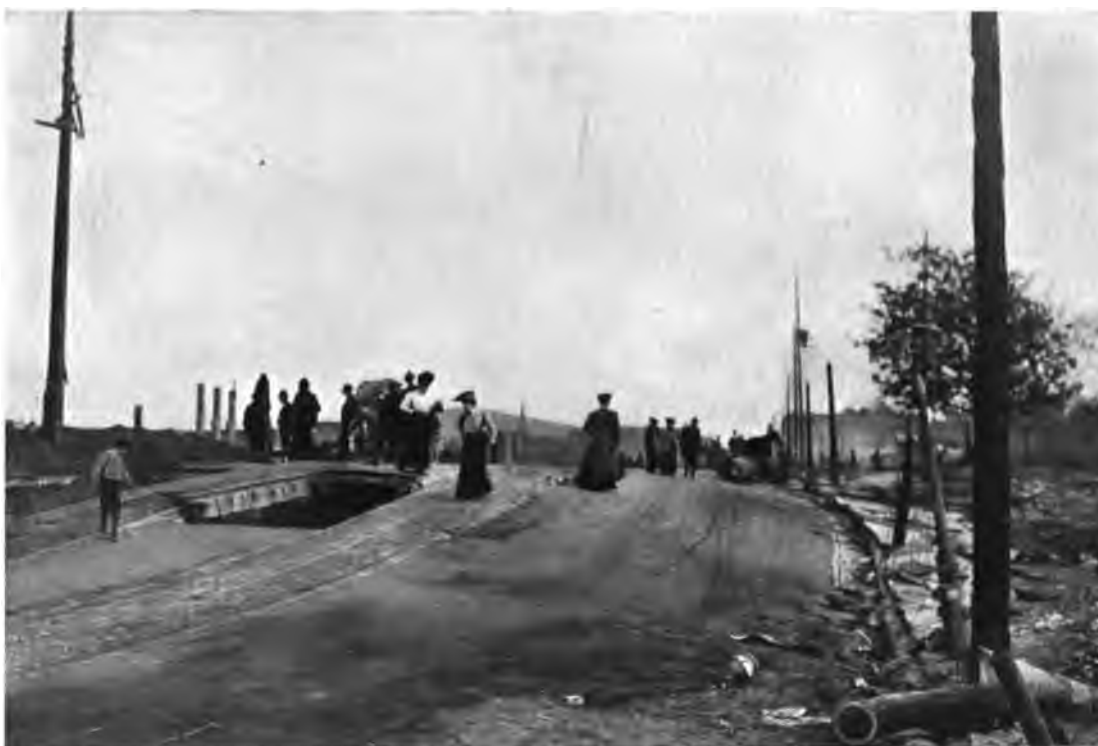
B. Valencia Street, near Eighteenth. Land in this neighborhood sank about 6 feet, flexing street surface. A. O. L.

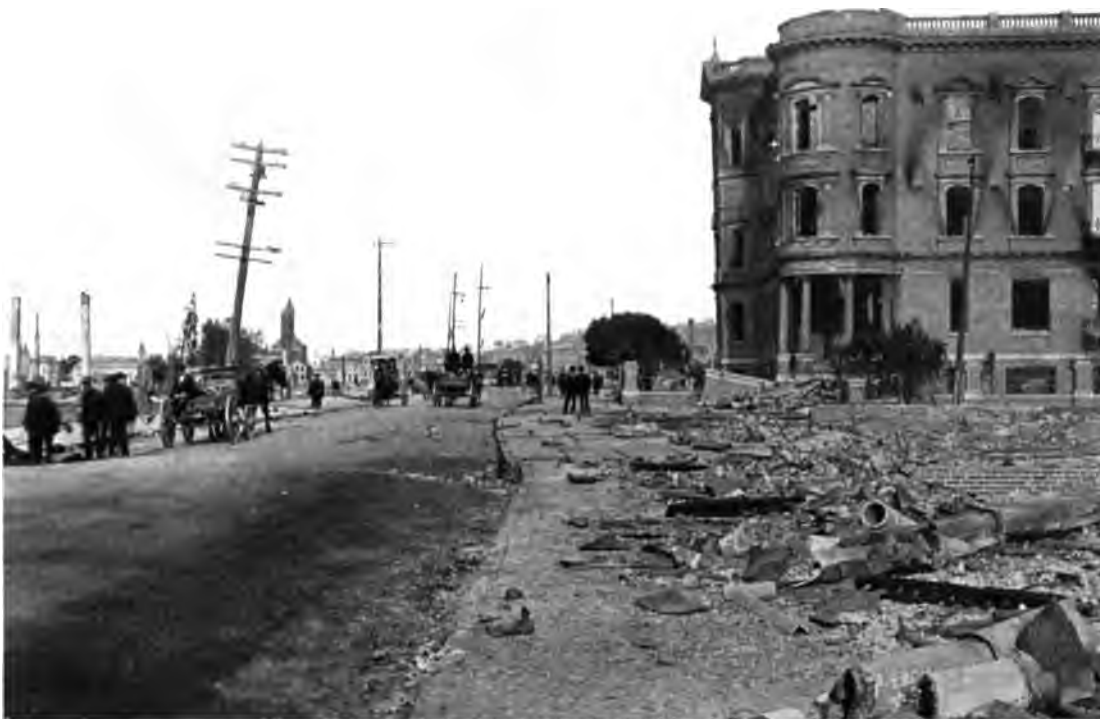
A. View along Nineteenth Street, from Guerrero Street. Both ground and buildings moved north about 6 feet toward center of old marsh, with component of movement down the channel. A. O. L.

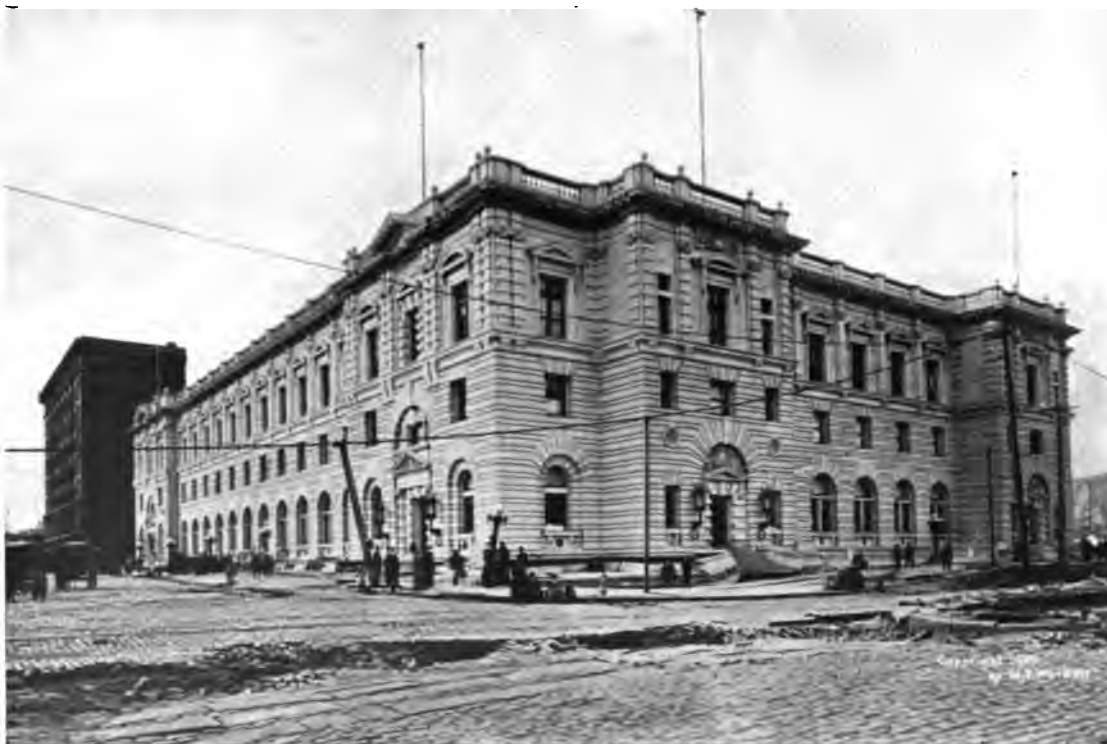
B. San Francisco Post-office, Mission and Seventh Streets. Near corner of building is on edge of old marsh. Ground over marsh sank and lurched. W. E. Worden, Photo.

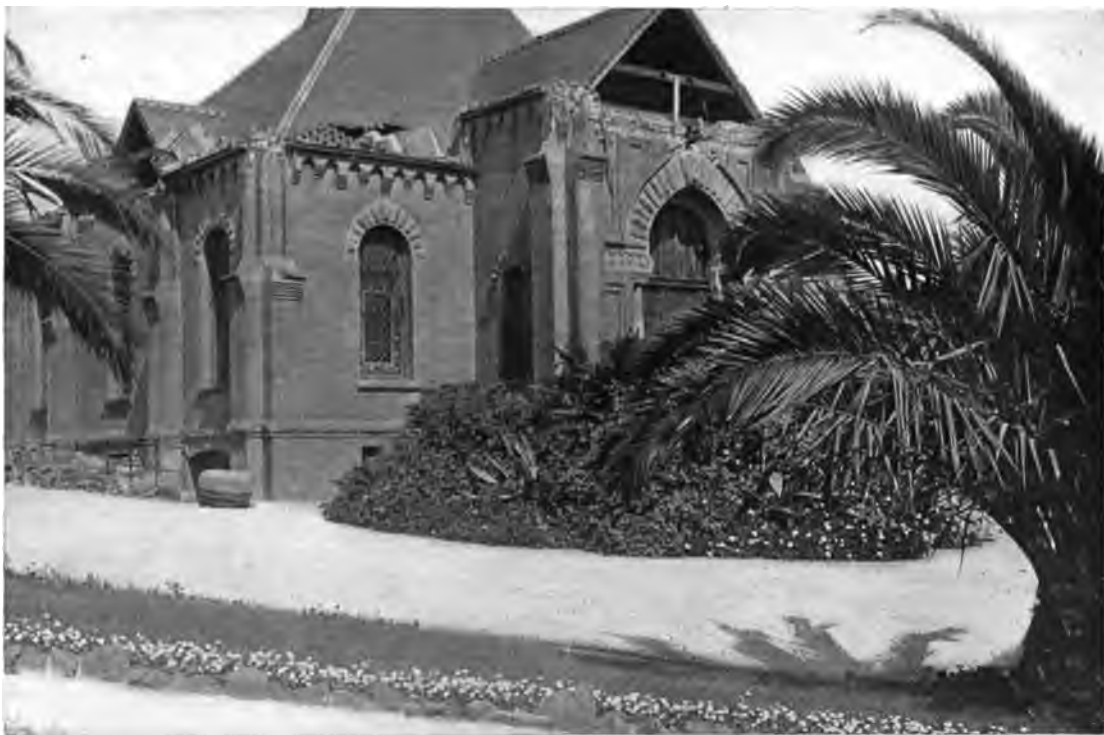
B. Hills of Eternity Cemetery, south of San Francisco. All four gables thrown out. Parapets thrown in on roof. A. O. L.

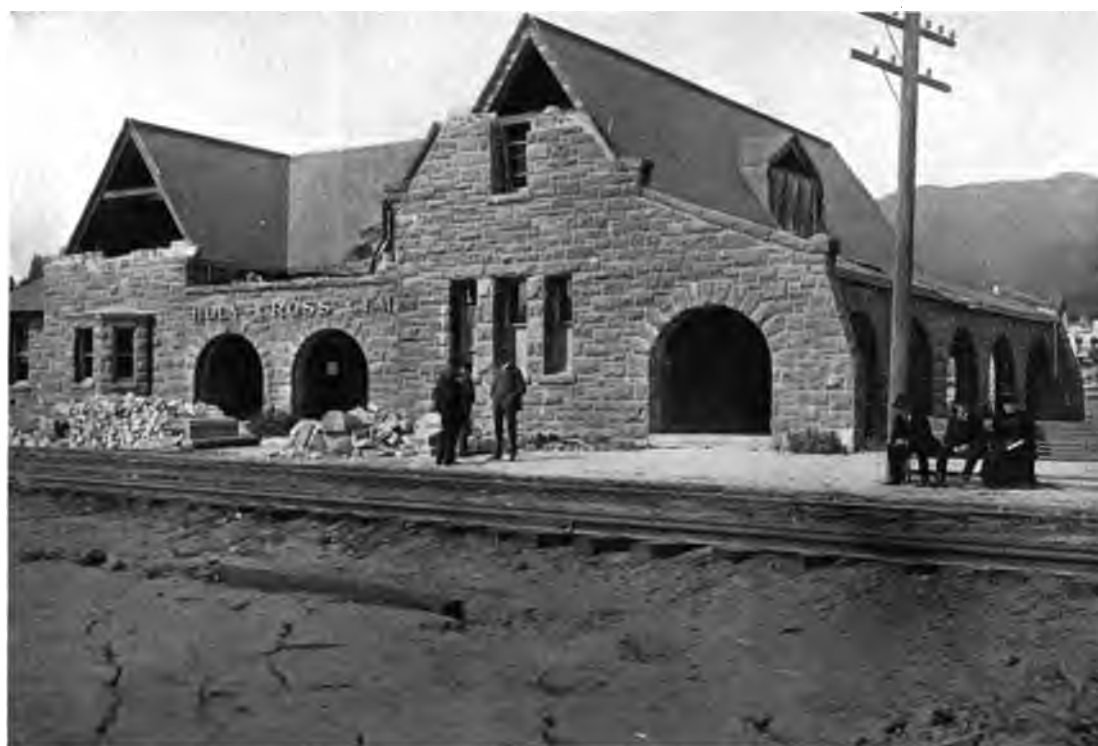
A. Holy Cross Cemetery Station, south of San Francisco. Building on made ground. A. O. L.

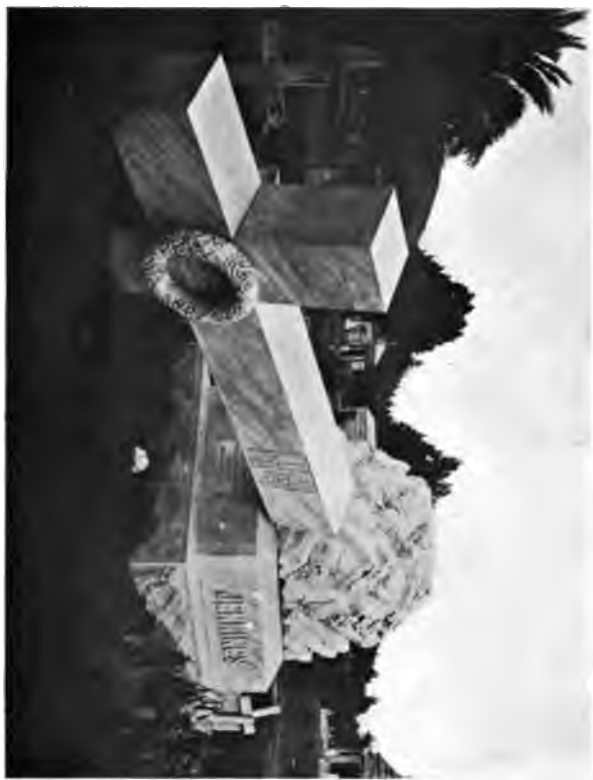
A. Overthrown monument, Holy Cross Cemetery. D. B. M.

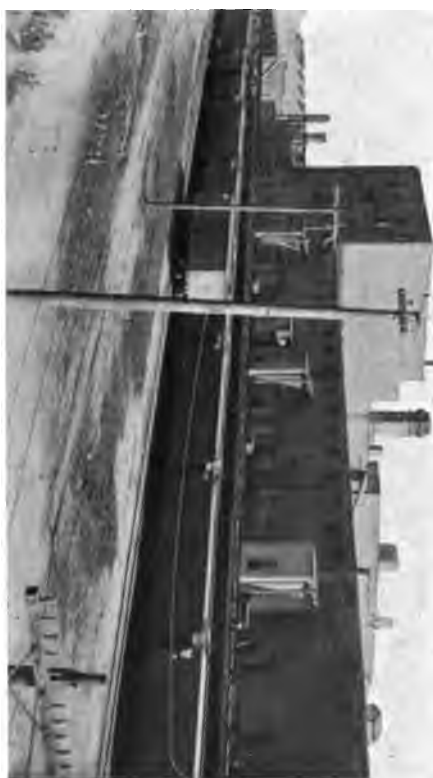
B. Brick building and high chimney left standing. South San Francisco. D. B. M.

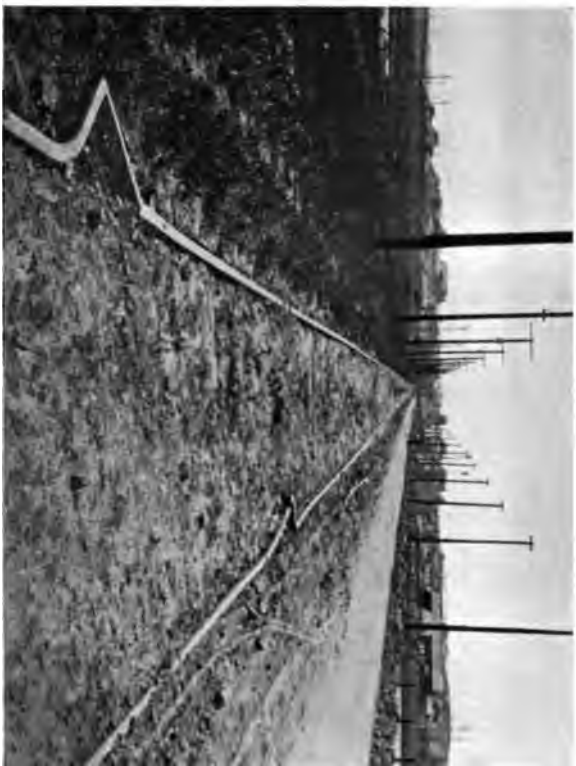
C. Roadbed and rails of electric railway on marsh west of San Bruno. D. B. M.
